Conservation and Extension of Evans' Home, Kilkenny for the new Butler Gallery.

Evans' Home 2012

Background to the project & importance of adaptive re-use of buildings in Kilkenny

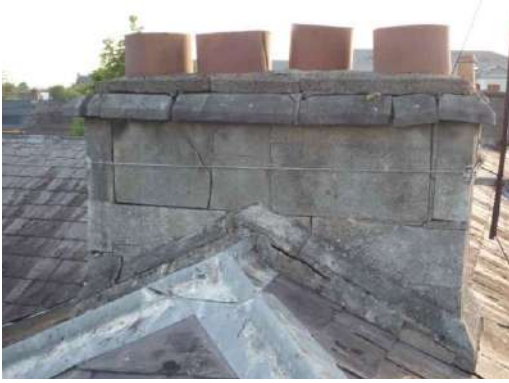
Chimney before repairs 2011

The project has been designed carefully in line with the principles of the current conservation practice, incorporating the principles of reversibility. A huge body of work was done on site investigations, archaeology, building surveys & materials analysis as well as research projects carried out by Butler Gallery on social history. Preliminary conservation works were carried out in advance of the main project with grant-aid from the Heritage Council, including renewal of cast iron gutters & downpipes in 2010, repair or rebuild of 8 stone chimneys in 2011 and in 2012 the 4 external stone doorcases were restored.

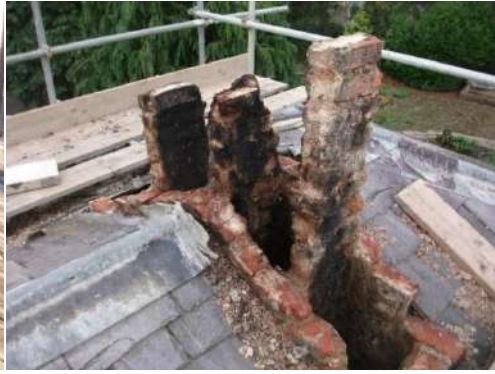
Repair/rebuild underway 2011

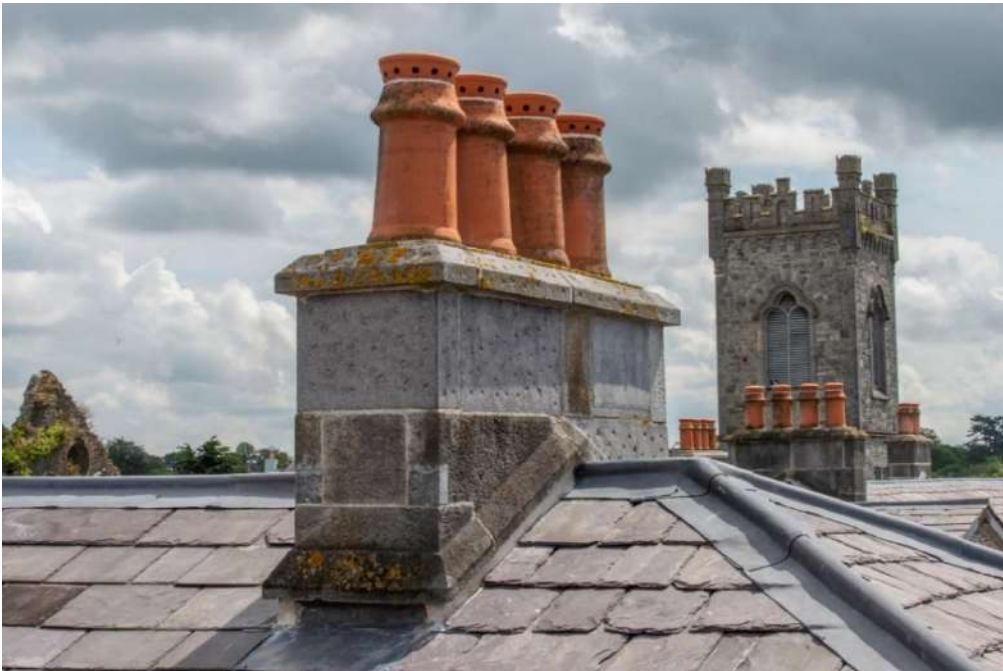
Completed works to roof and chimneys 2019

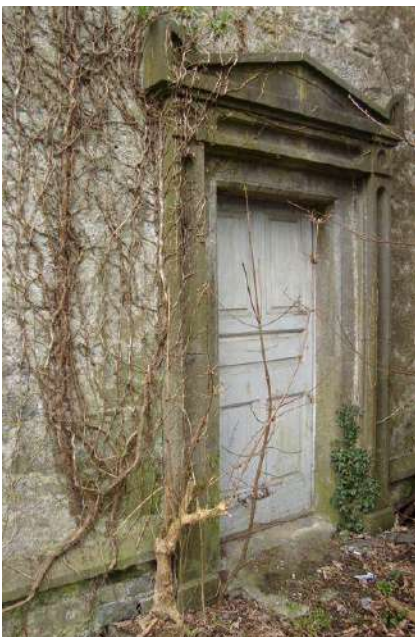
Doorcase before repairs 2012

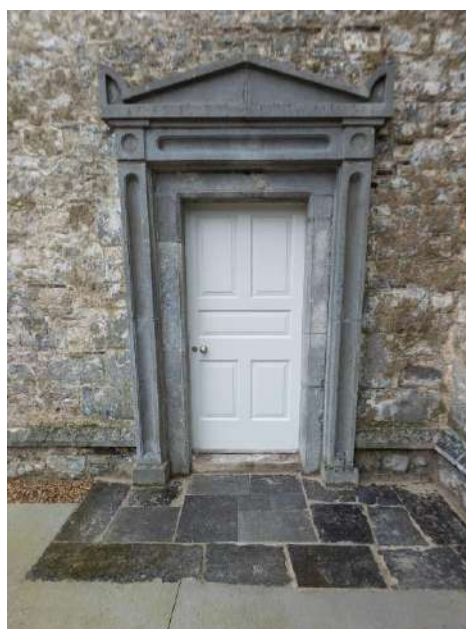
Doorcase in completed project

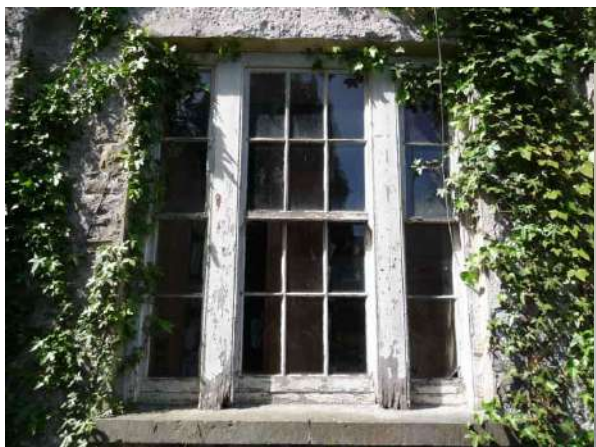
Five original windows remained in the building; these are located on the rear elevation and were conserved and restored. The remainder of the windows dated to the mid- 20th century and were in poor condition and of no architectural merit; these were replaced with windows to match the original design.

Original Wyatt window before restoration

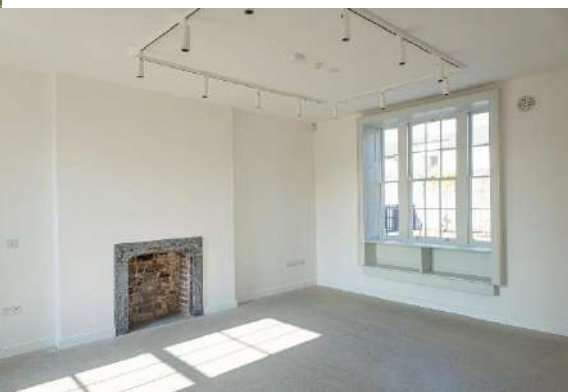
Wyatt window restored in Café

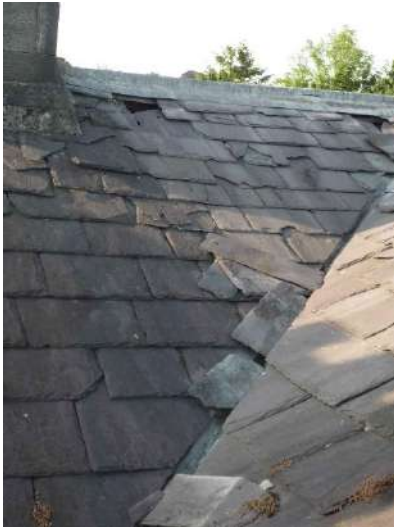
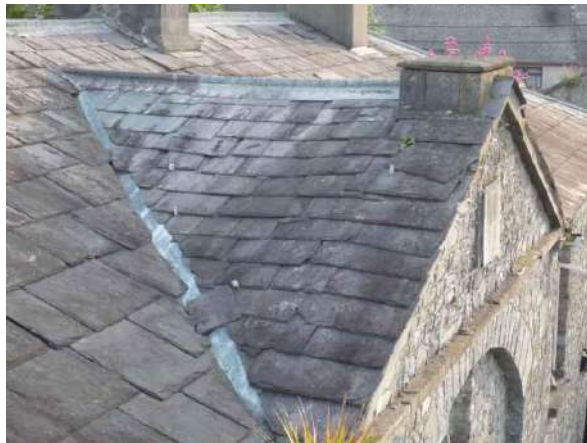
Roof slates & flashing in poor condition prior to repair

The existing roof has been repaired using the existing slates; new slates were chosen to match the existing in size and material. Careful repairs were carried out where necessary to the roof structure and replacement timbers kept to a minimum

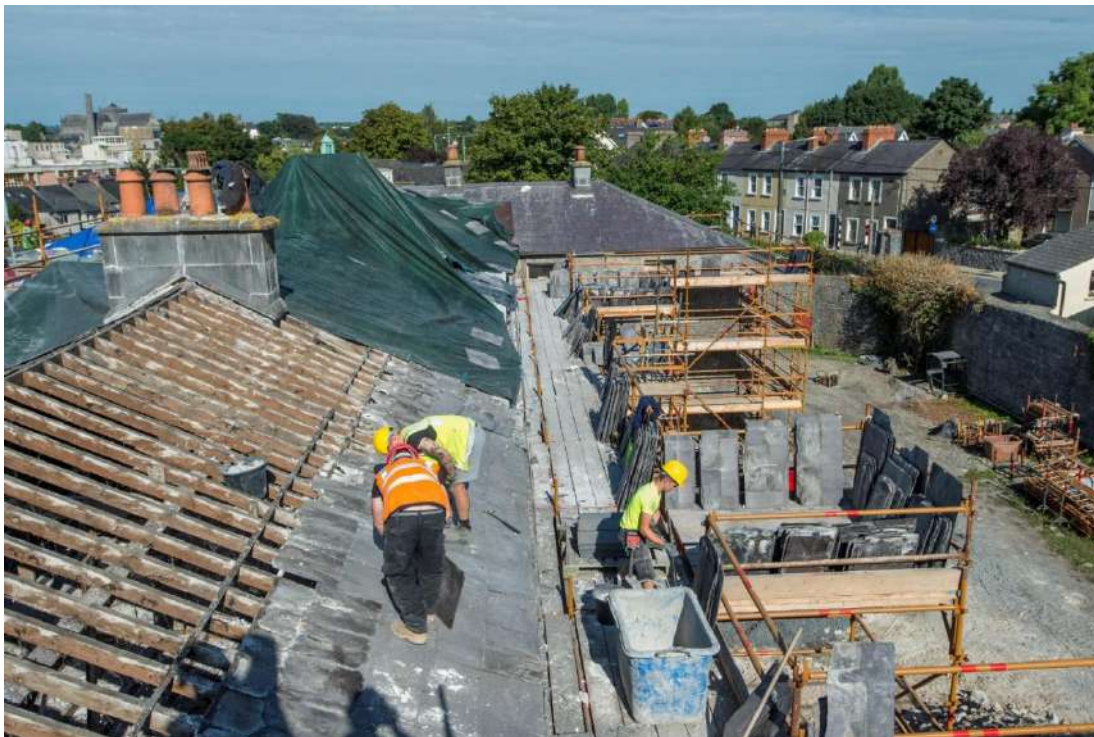
Re-slating underway

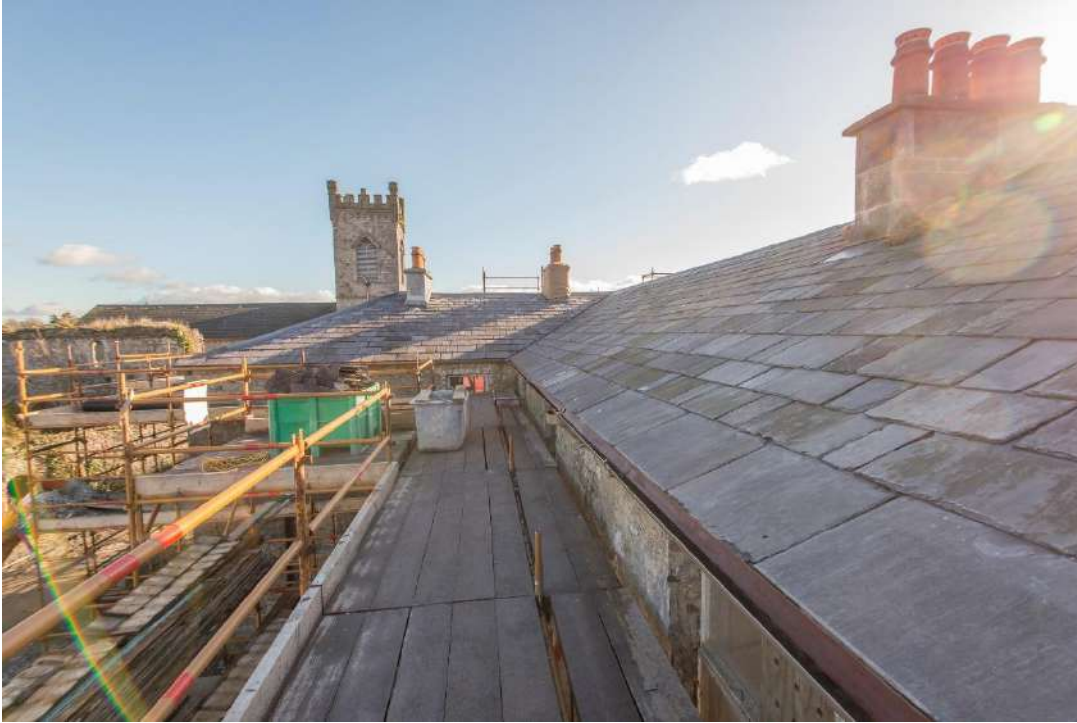
Re-slating completed

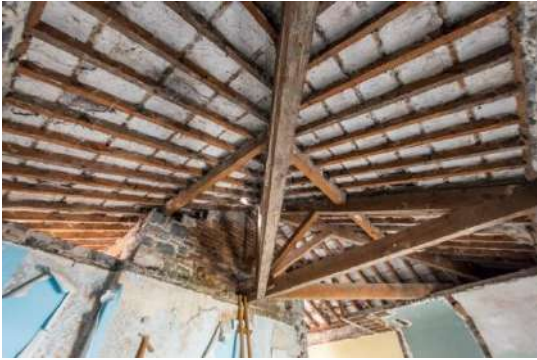
Roof structure stripped back

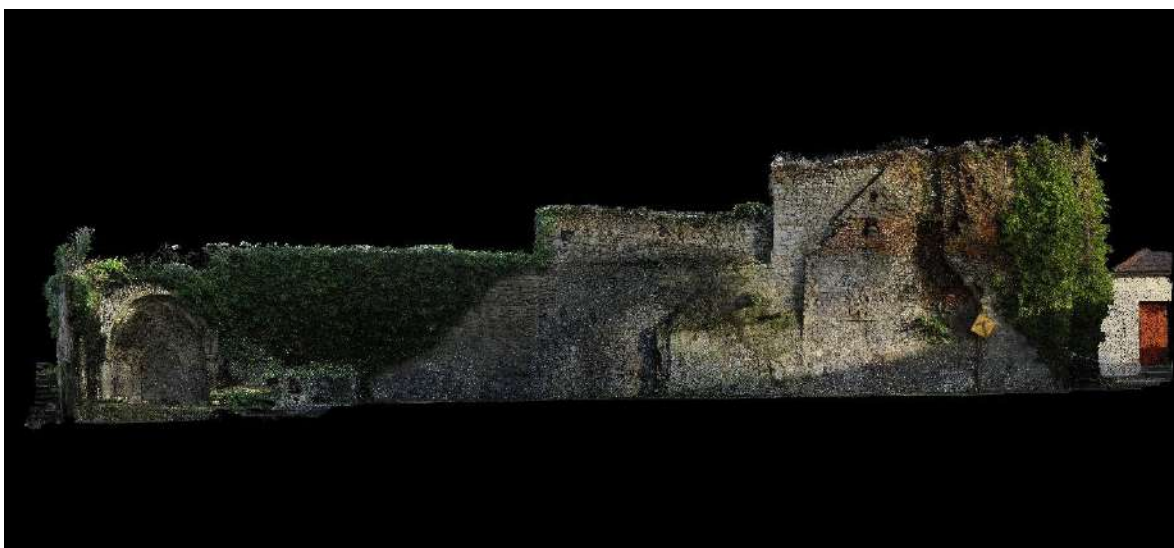
Detailed scan of perimeter wall in SE corner-south elevation

Sections of perimeter wall at the South East corner of the site contain significant amounts of medieval fabric; stabilization and conservation works will be undertaken on this by Kilkenny County Council in the near future.

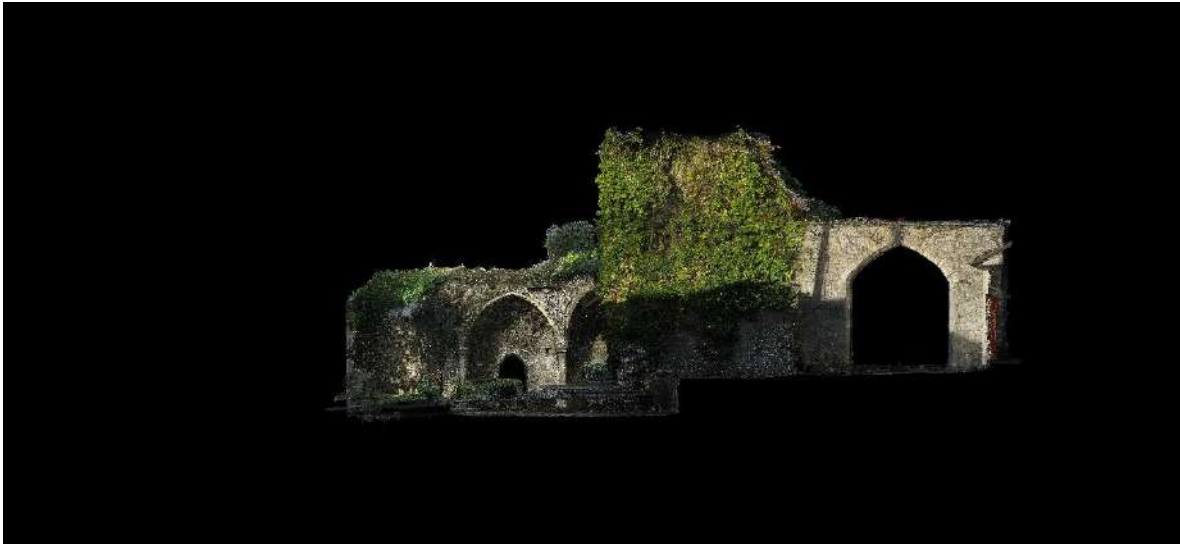
Detailed scan of wall in SE corner-east elevation

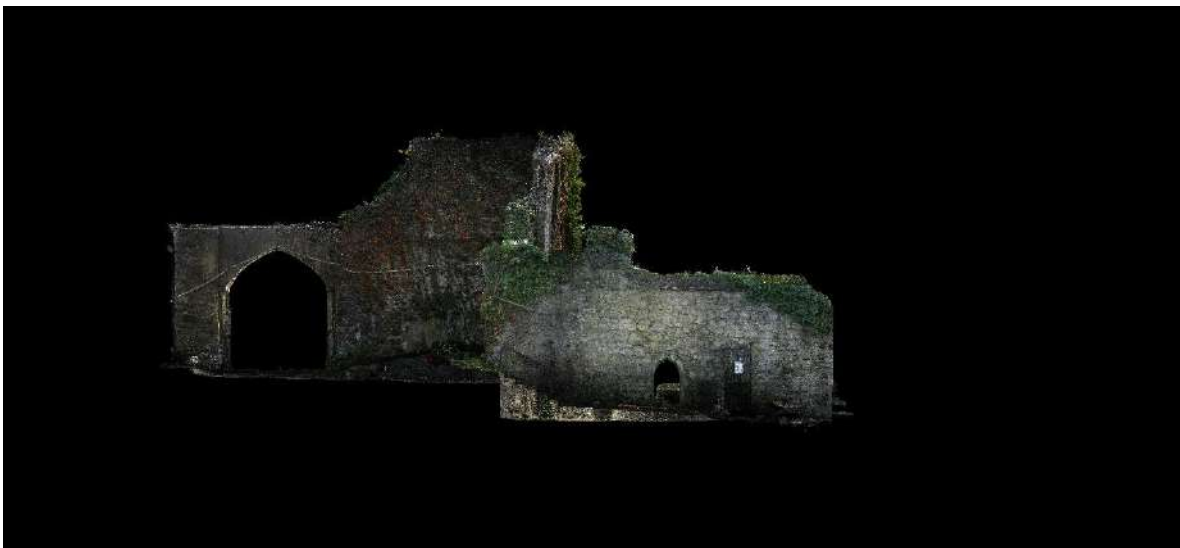
Detailed scan of wall in SE corner-west elevation
