Conservation and Extension of Evans' Home, Kilkenny for the new Butler Gallery.

Evans' Home 2012

Background to the project & importance of adaptive re-use of buildings in Kilkenny

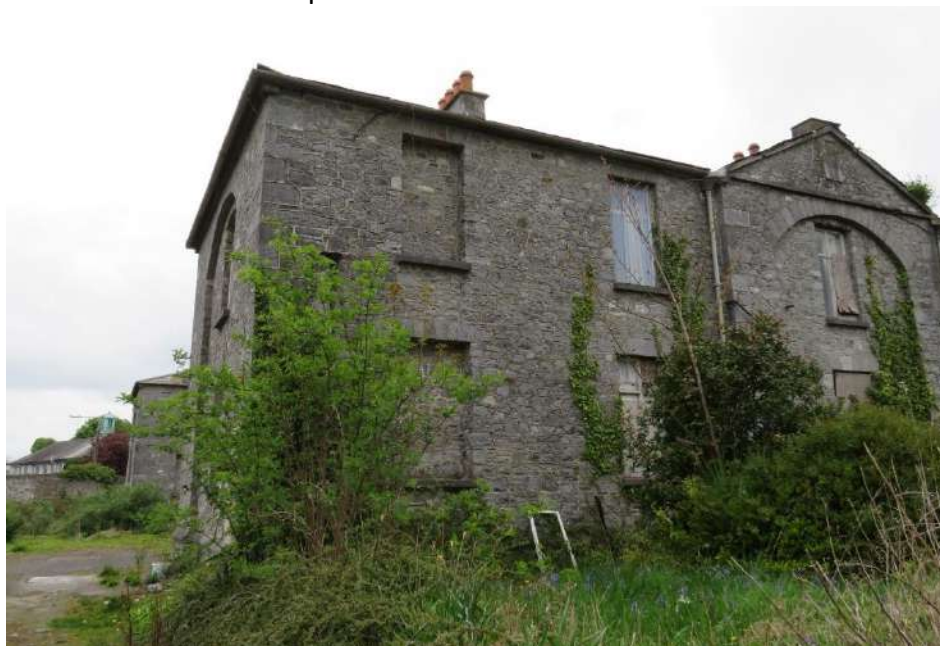
View south wing in 2016

The exterior has been re-pointed which involved the removal of the sand & cement strap pointing on the elevations and replacement with lime mortar.

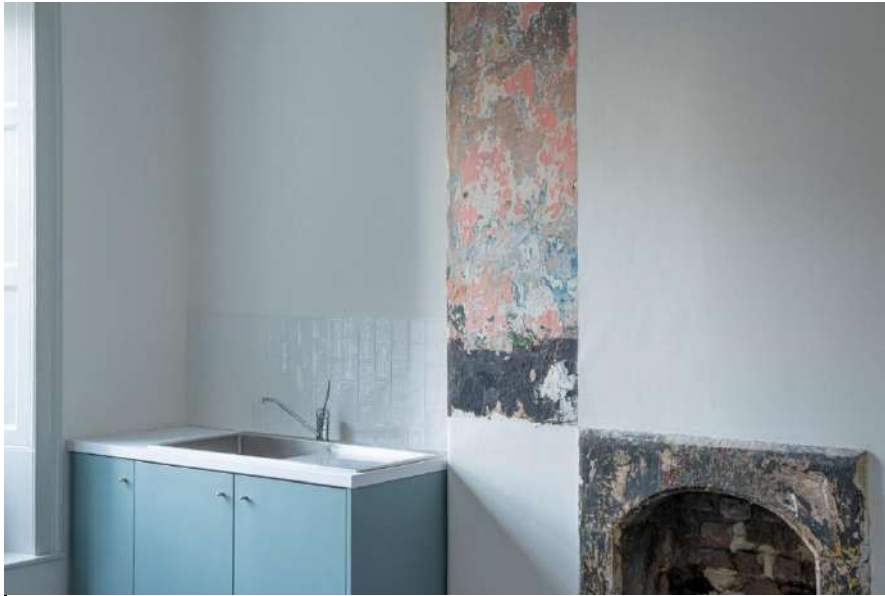
Learning Centre wet area- note original fireplace & “peintimento” wall panel

Original fireplace surroundings were refurbished and retained in situ where possible.

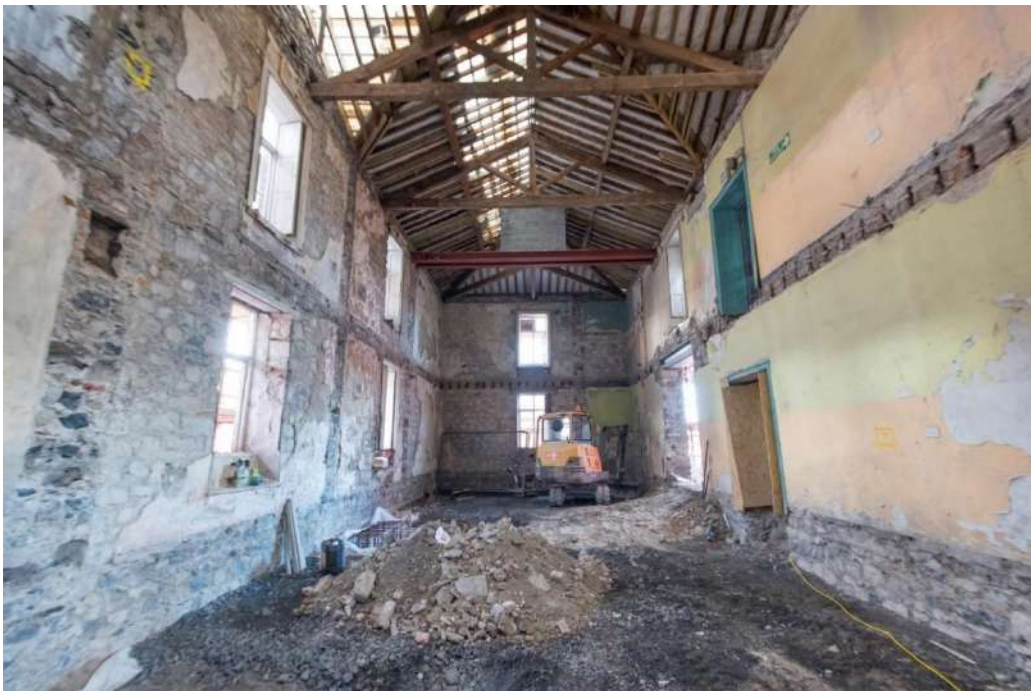
Main gallery space following demolition of internal walls & floor

In the right hand wing as you look at the front of the building the cross walls and first floor have been removed to accommodate the Main or temporary gallery. The double height gallery space has been internally lined out to provide a modern ‘box-in-box’ construction. As noted above, the deliveries door to the gallery required one of the windows to be enlarged and brought to the floor.

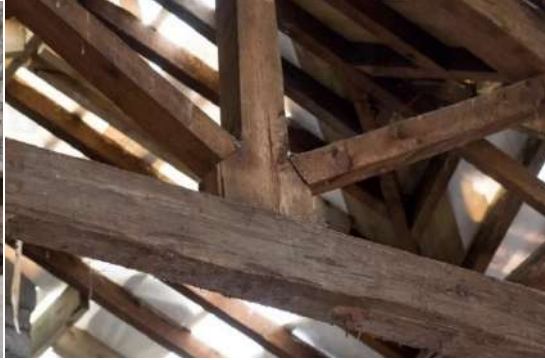
Roof truss detail

Internal window joinery was conserved; existing internal doors were conserved and fire-proofed. Careful repairs were carried out where necessary to the roof structure, replacing timbers kept to a minimum

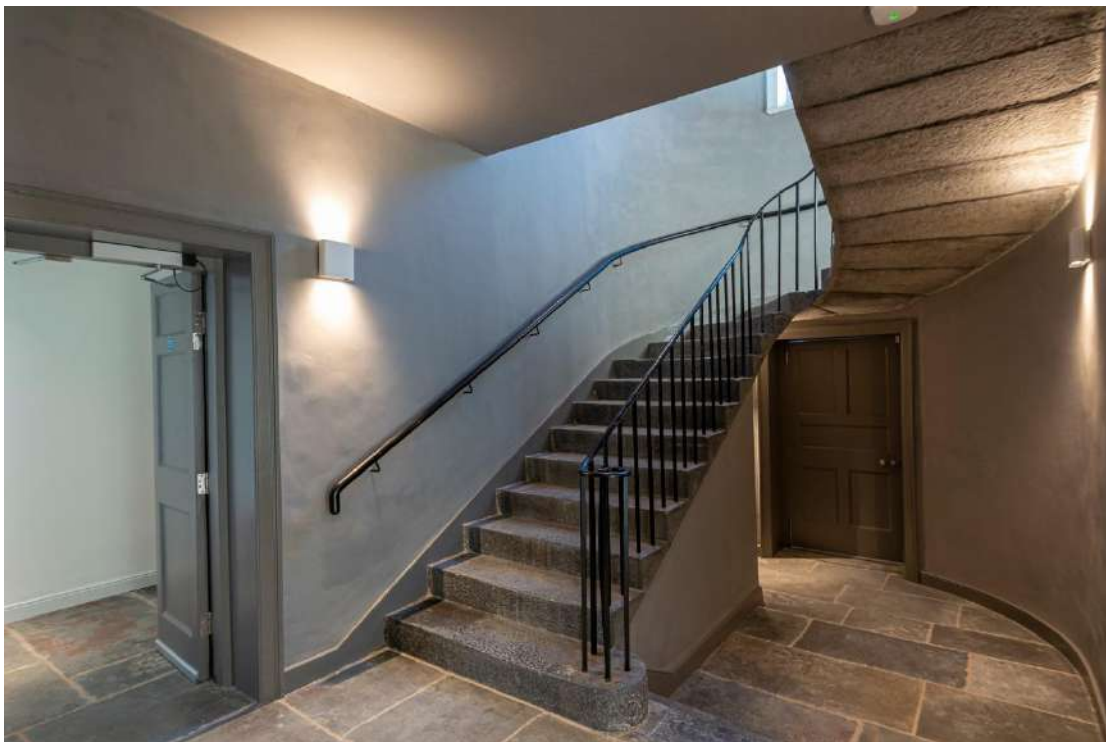
Staircase at north end-note the limestone flagged floor re-laid

Existing stone floors were retained, restored and relaid in hallways and corridors on the ground floor.
